Special Storm Report, Los Angeles River Watershed Flood Control Project

This report is to present a preliminary evaluation of the performance and benefits of works of improvement, installed under the flood control authorization, during flood flows in the storm period of January 15-18, 1952. It also contains estimates of flood water and sediment damages in unprotected subwatersheds within the project area, in the San Fernando Valley Soil Conservation District.

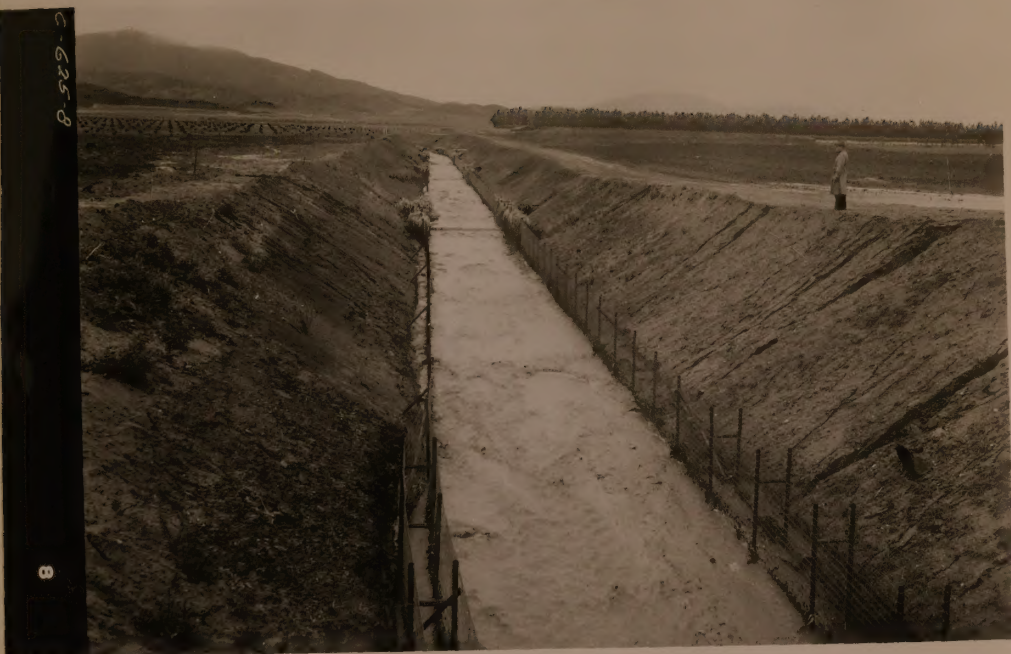
(2) Bell Creek Flood Channel near the Canoga Park High School. 500 yards downstream this channel combines with the improved Calabasas Flood Channel to form the Los Angeles River. During the storm years of 1938, 1941 and 1943, 1 to 2 feet of water covered the floors of the school building in the right of this picture, as well as most of the homes in the town of Canoga Park in the background and left of the picture. On each of the above mentioned years, 80 people were ferried by boat to high grounds out of the lower areas in Canoga Park along this channel. The high water line of the storm of January 17, 1952 can be seen along the right bank in the picture. During the storm peak water flowed 6 inches deep into the street over the left side of the channel. There was no damage to homes or business.

(2) Bell Creek flood channel near the Omega Park High School. 500 yards downstream this channel connects with the improved Calaveras flood channel to form the Los Angeles River. During the winter years of 1937, 1941 and 1945, 1 to 2 feet of water covered the floors of the school building in the right of this picture, as well as most of the homes in the town of Omega Park in the background and left of the picture. In each of the above mentioned years, 30 people were hurried by boat to high grounds out of the lower areas in Omega Park along this channel. The high water line of the storm of January 17, 1937 can be seen along the right bank in the picture. During the storm peak water flowed 8 inches deep into the street over the left side of the channel. There was no damage to homes or business.

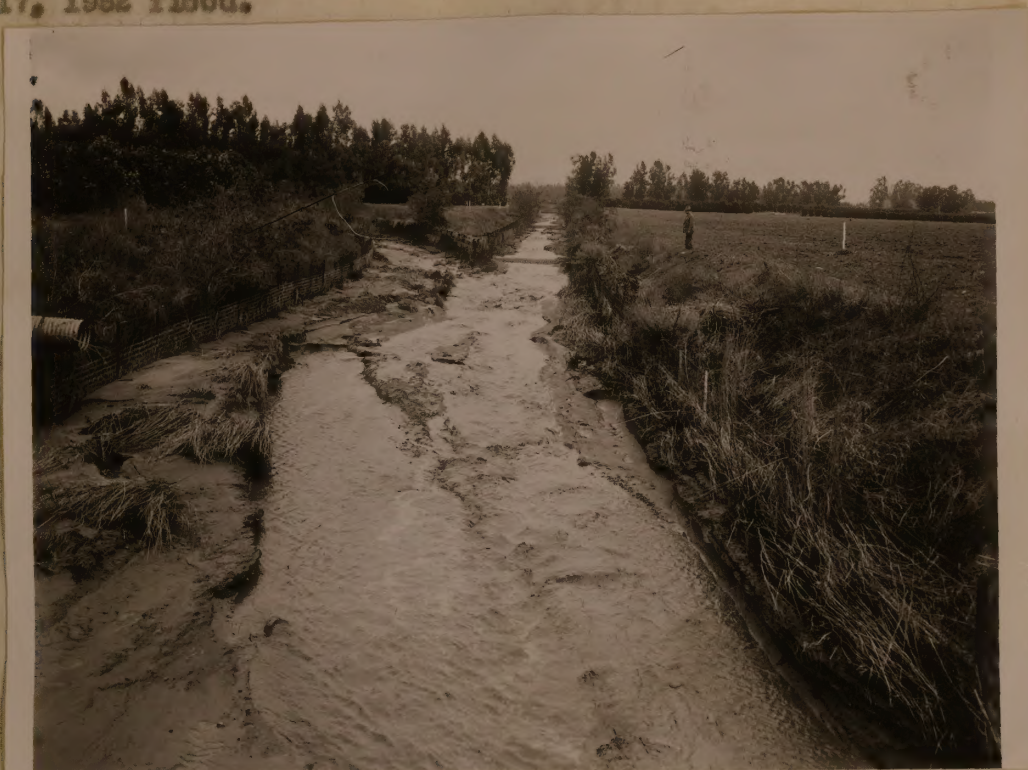
(3) View of the Wilbur Creek Flood Channel in the orchard lands north of Northridge in the San Fernando Valley. Peak flows were within 12 inches of the top of the revetment during the January 17, 1962 flood.

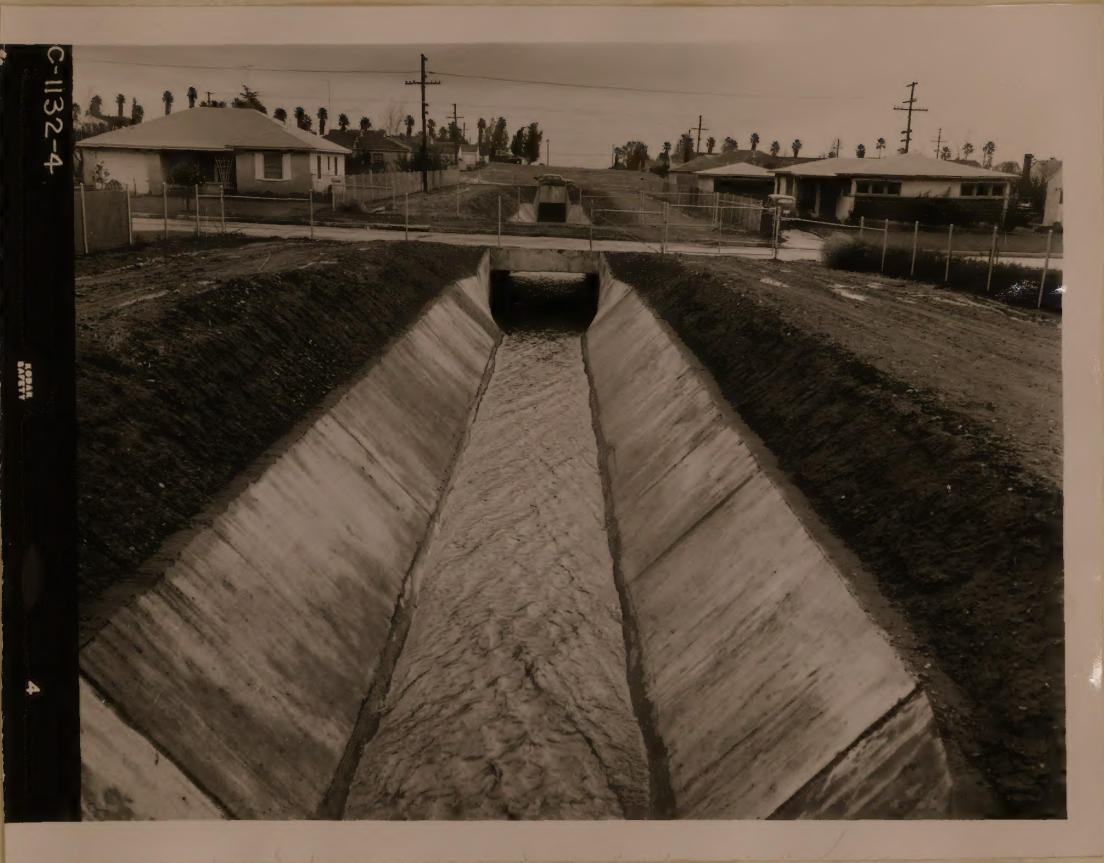
(4) View of the confluence of Wilbur and Aliso Creeks near Northridge in the San Fernando Valley. The depth of flow in these channels was within 6 inches of the top of the revetment during the January 17, 1962 flood. The  $3\frac{1}{2}$  miles of flood channel shown in this and the above photo functioned perfectly to relieve flood damage to agricultural lands through the improved portions of the watershed. This was a cooperative project constructed by the Soil Conservation Service under contract in cooperation with the Los Angeles County Flood Control District.

(6) View of the confluence of Wilbur and Wilcox creeks near Fortbridge in the San Fernando Valley. The depth of flow in these channels was within 8 inches of the top of the revetment during the January IV, 1933 flood. The 8 1/2 miles of flood channel shown in this and the above photo threatened seriously to relieve flood damage to agricultural lands through the improved portions of the watershed. This was a cooperative project conducted by the Soil Conservation Service under contract in cooperation with the Los Angeles County Flood Control District.

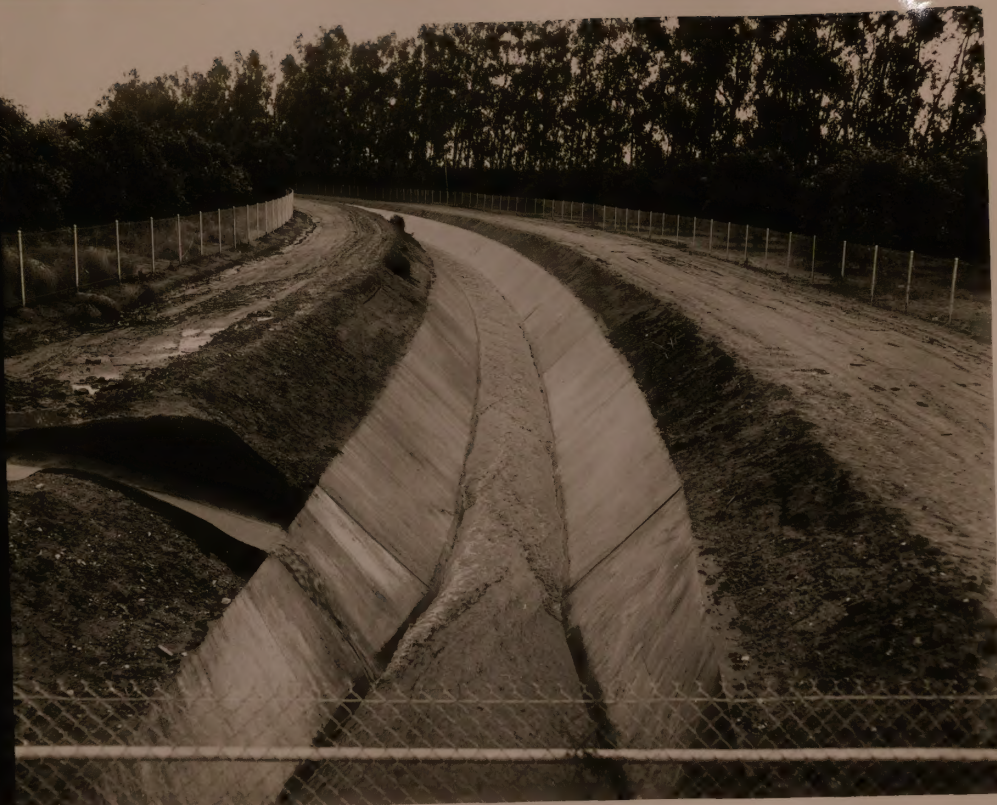
(5) View of the Wilson-East flood channel near the west edge of San Fernando, California

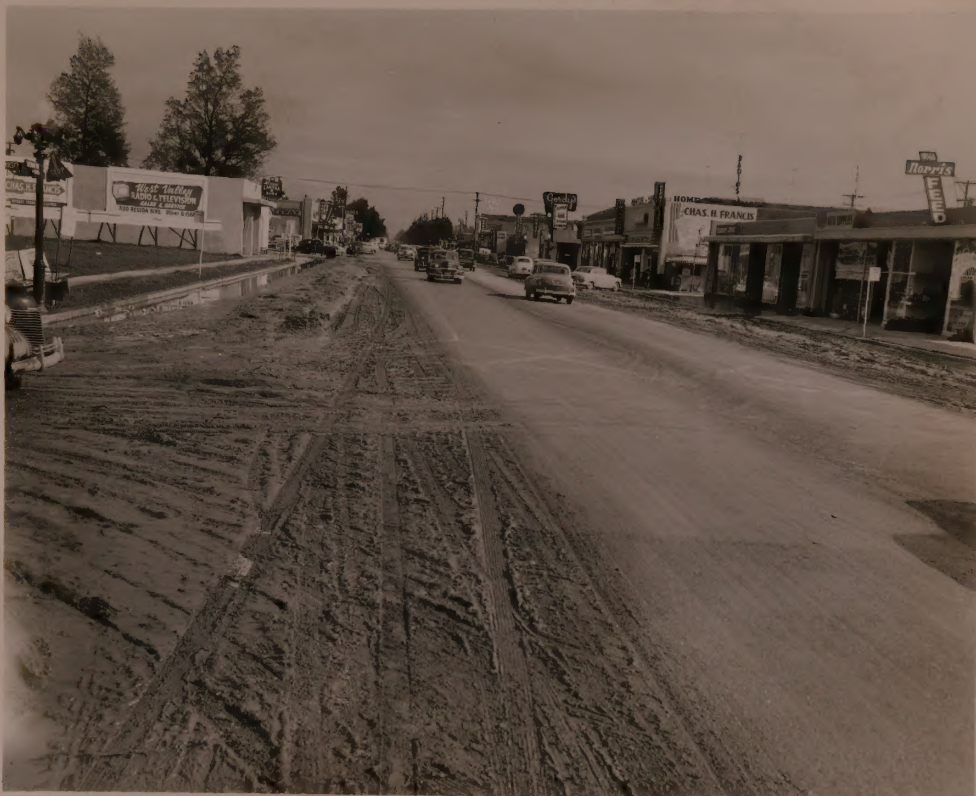
(6) View of the Wilson-East flood channel through citrus groves near San Fernando, California. This channel flowed at  $2/3$  capacity during the flood flow of January 17, 1962, diverting all waters from the upper watershed lands away from the agricultural lands, the community of Sepulveda and Sepulveda Blvd., one of the principal access highways from Bakersfield to Los Angeles. This was a cooperative project constructed by the Soil Conservation Service under contract in cooperation with the City of Los Angeles and the Los Angeles County Flood Control District.

(6) View of the Wilson-Frost flood channel through  
olive grove near San Fernando, California. This  
channel flowed as S.E. gully during the flood flow  
of January 17, 1932, diverting all waters from the  
upper watershed lands away from the agricultural  
lands, the community of Sepulveda and Sepulveda Div.  
one of the principal sources of water from Santa Monica  
to Los Angeles. This was a cooperative project con-  
ducted by the Soil Conservation Service under con-  
tract in cooperation with the City of Los Angeles and  
the Los Angeles County Flood Control District.

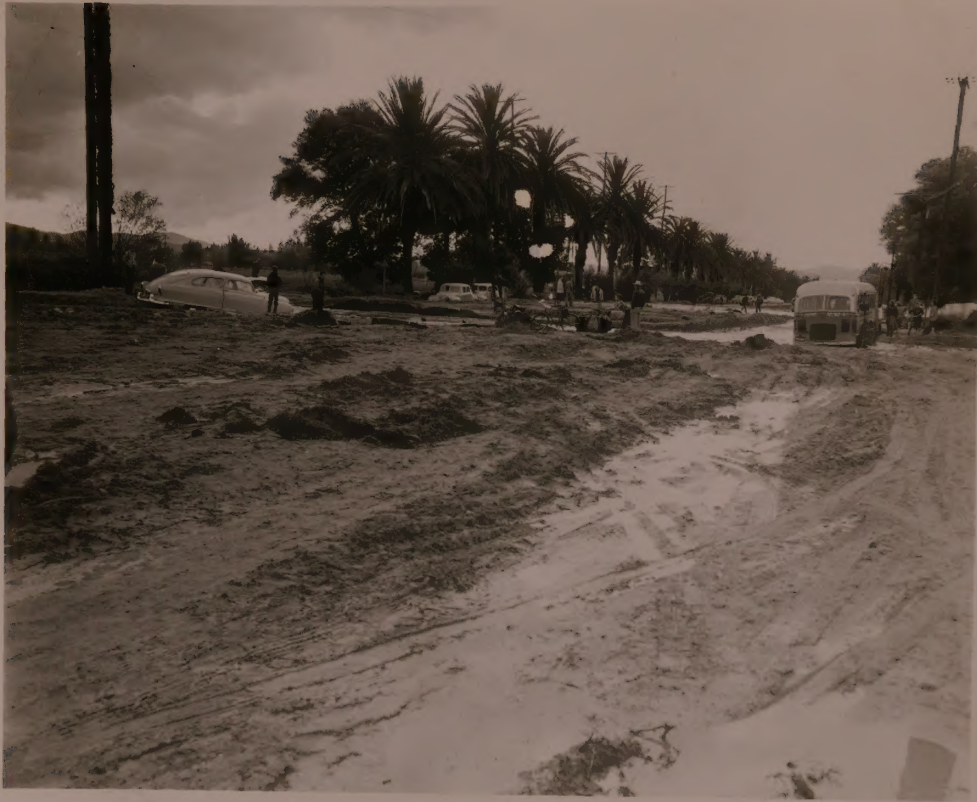
(7) View of the main street, Sherman Way, through the town of Reseda after the January 17, 1952 flood. Eighty people were evacuated from homes in this community during the height of the floods on January 15 and 17, 1952. Damage to stores and residences in this area is estimated at \$75,000.

(V) View of the main street, Shuman Way, through  
the town of Paradise after the January 17, 1933 flood.  
Many people were evacuated from homes in this com-  
munity during the height of the floods on January 18  
and 19, 1933. Damage to stores and residences in  
this area is estimated at \$75,000.

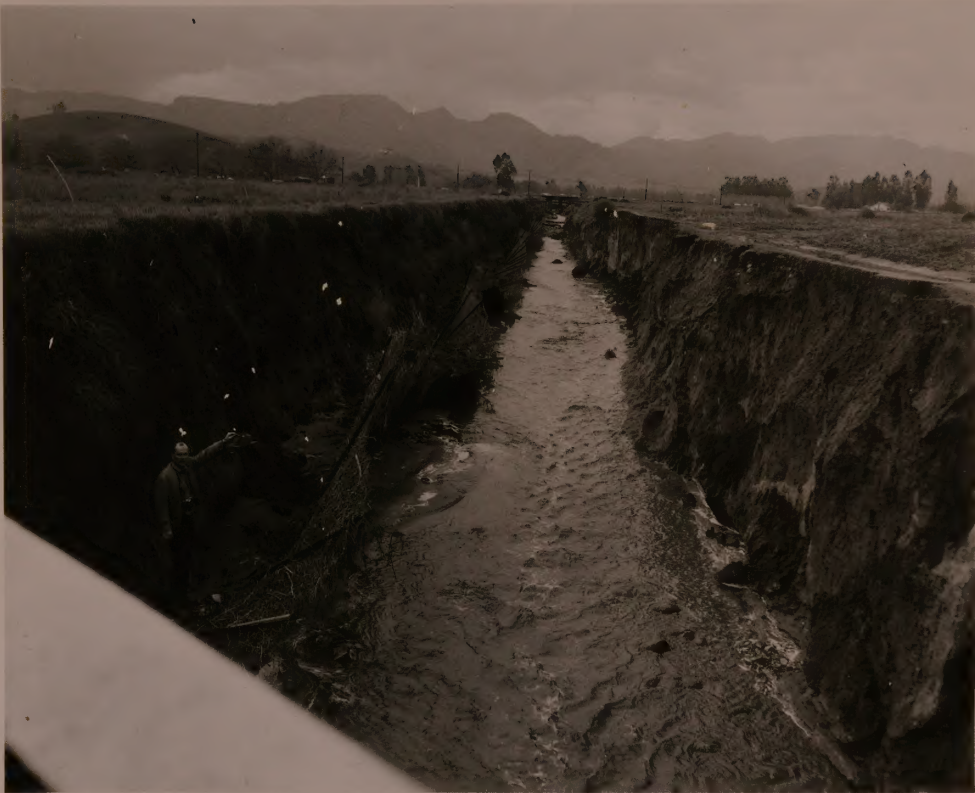
(8) View of deposition on Sherman Way west of Reseda, California caused by Browns Creek flowing toward the Los Angeles River in Mason Street. A Pacific Electric bus and four sedans, buried in the mud the night of January 17, 1952, can be seen in the background. Debris deposits from 5 feet deep to 1 foot deep occur along Sherman Way and adjacent agricultural lands for a distance of half a mile west and a mile to the east.

(3) View of deposition on Sherman Way east of  
Inverton, California caused by highway (view looking  
toward the Los Angeles River in Inverton Street. A  
Pacific Electric bus and four sedans, parked in the  
mid the night of January 17, 1938, can be seen in  
the background. Depth deposits from 5 feet deep to  
1 foot deep occur along Sherman Way and adjacent rights  
of way for a distance of half a mile west and  
a mile to the east.

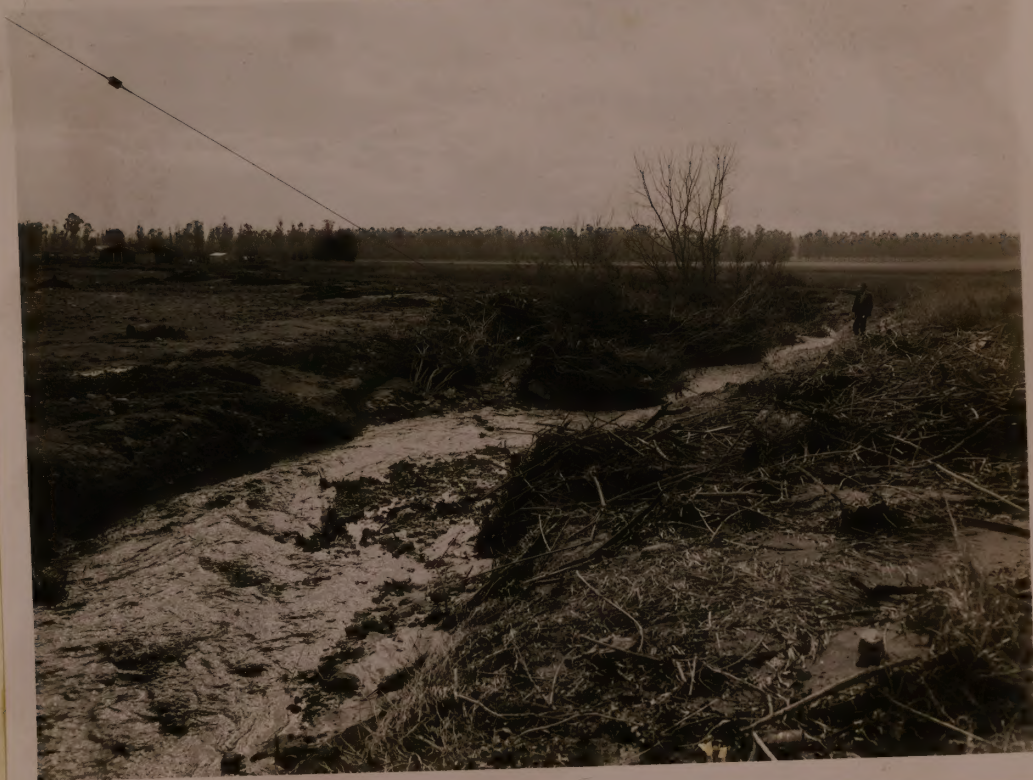
(9) View of Santa Susana Creek above its junction with Browns Creek near Chatsworth in San Fernando Valley showing gullying and destruction of inadequate revetment placed along one side of this channel by the property owner. The channel through this reach is 5 feet deeper and 100% wider as a result of the flood of January 17, 1952. The height of the flood flow is indicated by the man.

(2) View of Santa Susana Creek above its junction  
with Brown Creek near the north in San Fernando  
Valley showing gulping and destruction of lands  
grate pavement placed along one side of this  
channel by the property owner. The channel through  
this reach is a race gutter and 100' wider on a  
result of the flood of January 17, 1928. The height  
of the flood flow is indicated by the man.

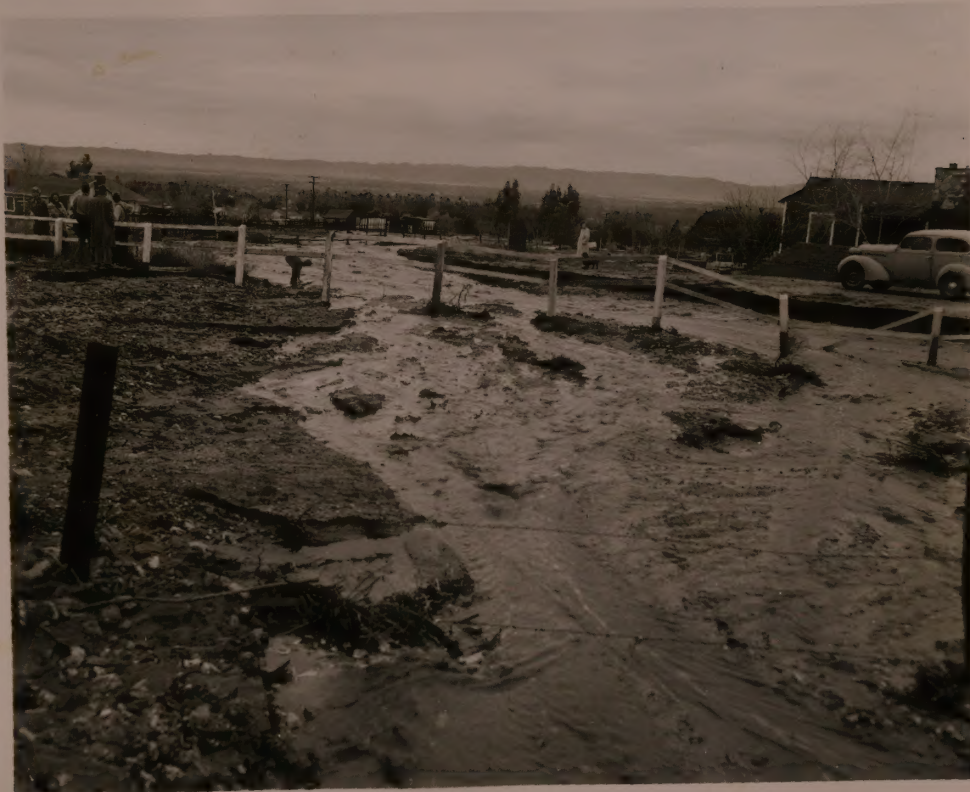
(10) View of Limakila Creek north and west of Northridge in San Fernando Valley. Loss of soil and deposition of brush and debris against ranch homes and agricultural lands can be seen in the left background of this picture.

(10) View of Lincoln Creek north end west of  
Hortland in San Francisco Valley. Line of soil  
and deposition of debris and debris against ranch  
house and agricultural lands can be seen in the  
left background of this photo.

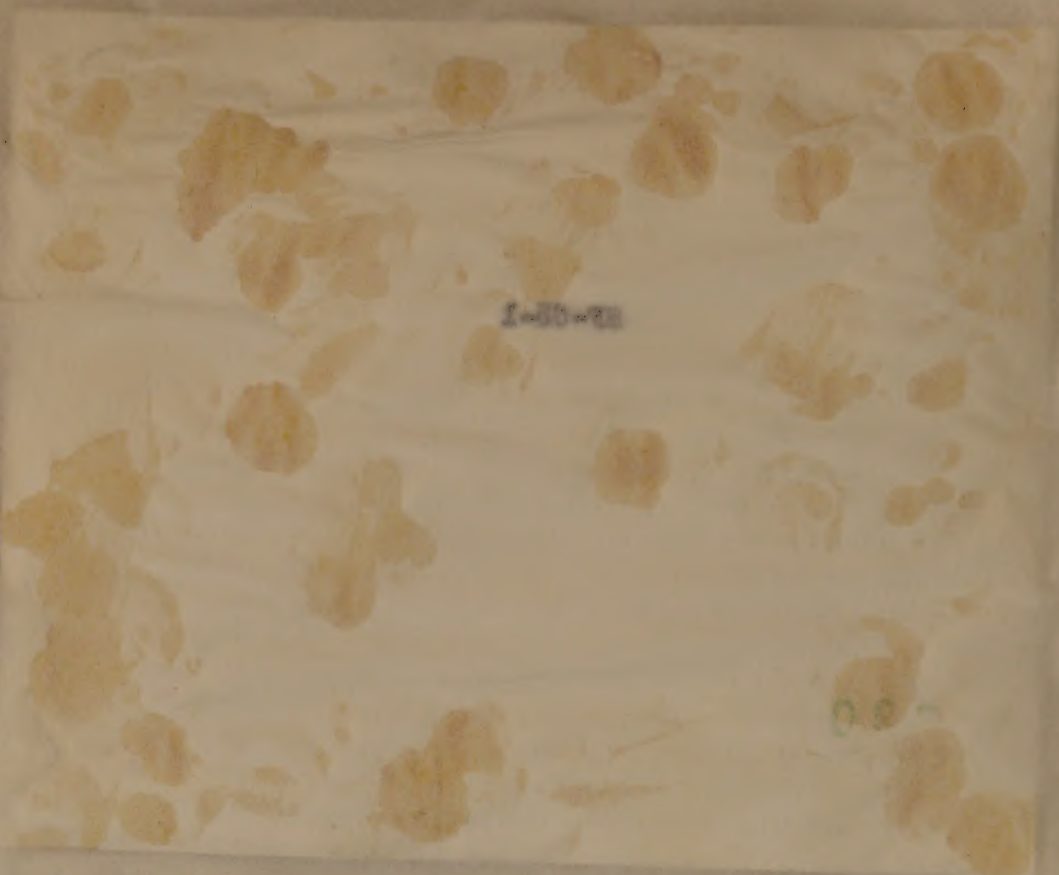
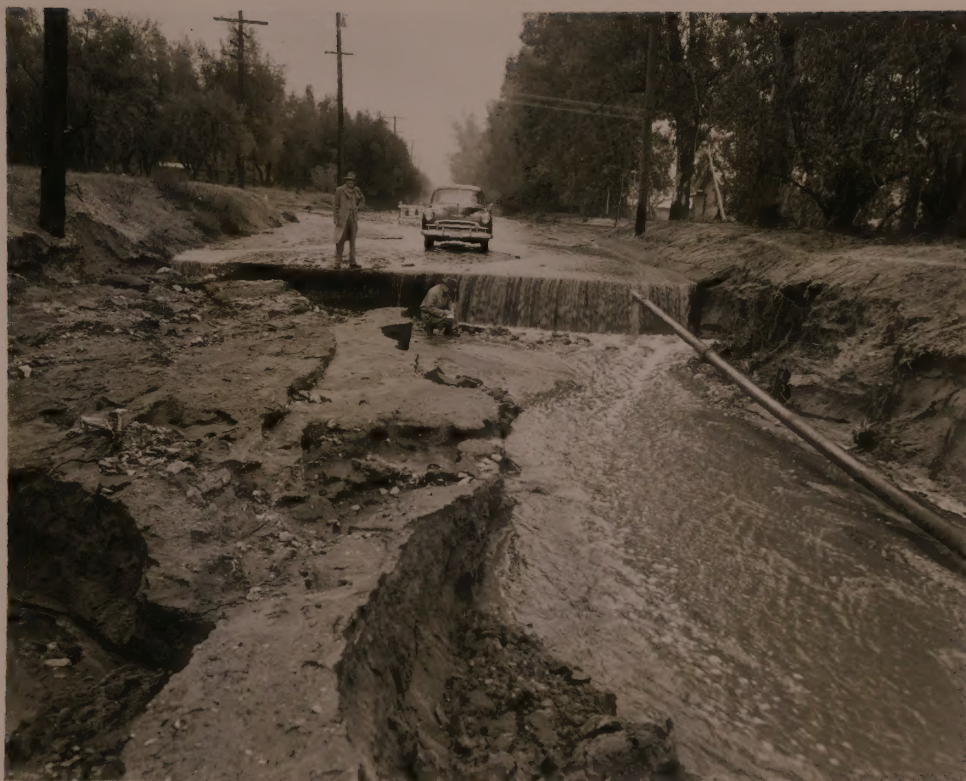
The channel works in the upper-two-thirds of the watershed have not been completed as yet. Typical damage is shown in pictures (11) and (12). The damage throughout this portion of the watershed was principally of four types and is tabulated in Table 1.

(11) View of the debris clogged May Canyon Wash as it flowed toward the homes northeast of San Fernando, California. The remaining channel depths are 6 to 10 inches after the flood flows of January 17, 1952. Should the channel breach its banks at this point, extensive damage would occur to homes and orchard areas on the slopes in this view.

(11) View of the debris along the canyon wall  
as it flows toward the point northeast of San  
Bernardo, California. The remaining channel  
depths are 6 to 18 inches after the flood flows  
of January 17, 1952. Within the channel breach  
ice banks at this point, extensive damage would  
occur to homes and orchard areas on the slopes  
in this view.

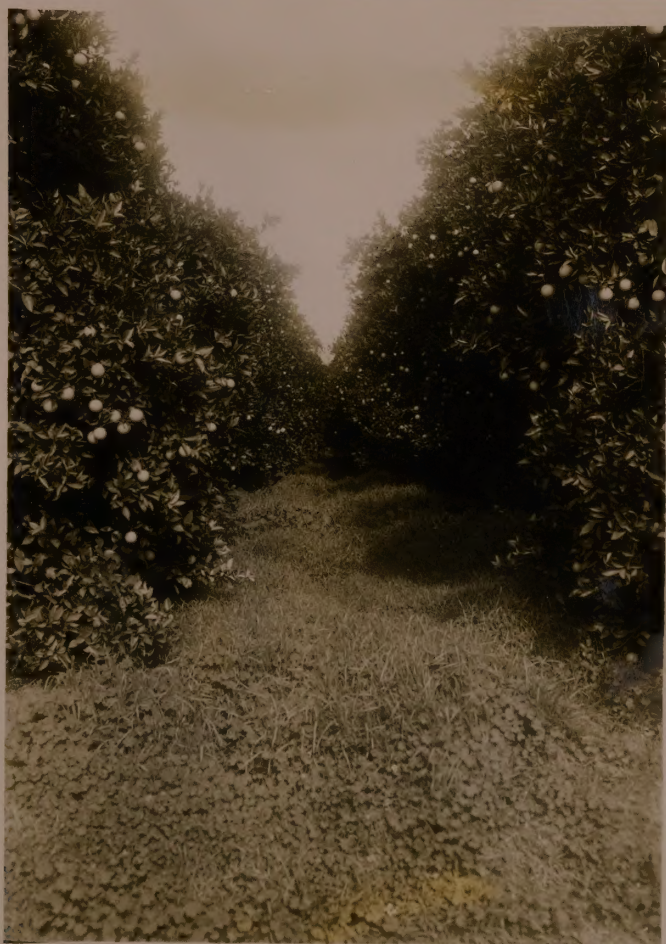
(16). Clean cultivated  
orchard. Loose soil  
moved easily. Burns or  
cross checks give way.  
Contrast with good  
cover or non-cultiva-  
tion management. (17)(18)

(17) Dense cover crop  
in orchard very effec-  
tive in preventing soil  
loss and cutting by  
excess water.

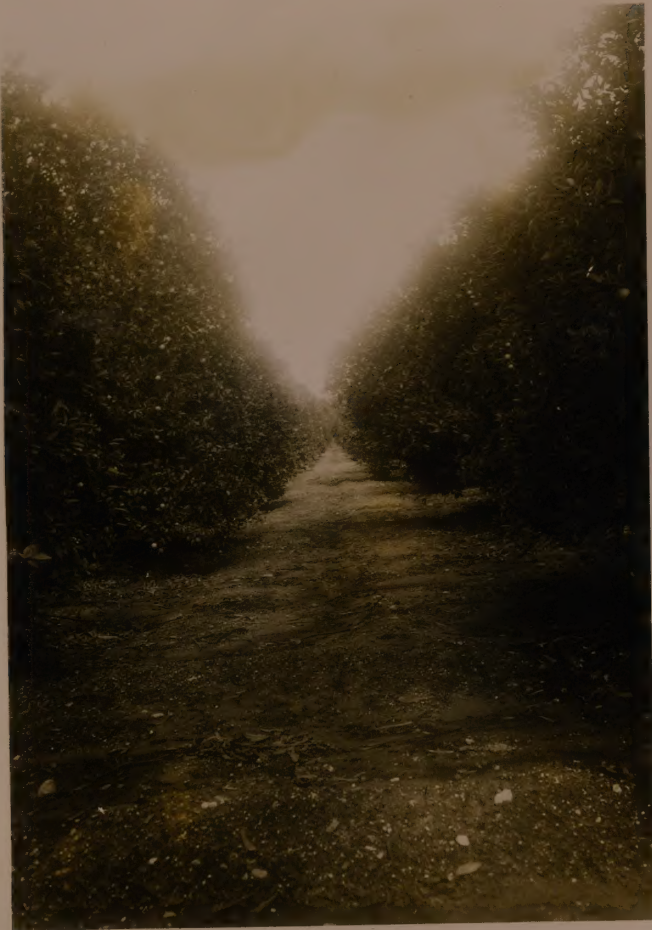
(16) Clean cultivated  
orchard. loose soil  
moved easily. Burns or  
crop checks give way.  
Contact with good  
cover or non-cultiva-  
tion management. (17)(18)

(17) Dense cover crop  
in orchard very effec-  
tive in preventing soil  
loss and cutting by  
excess water.

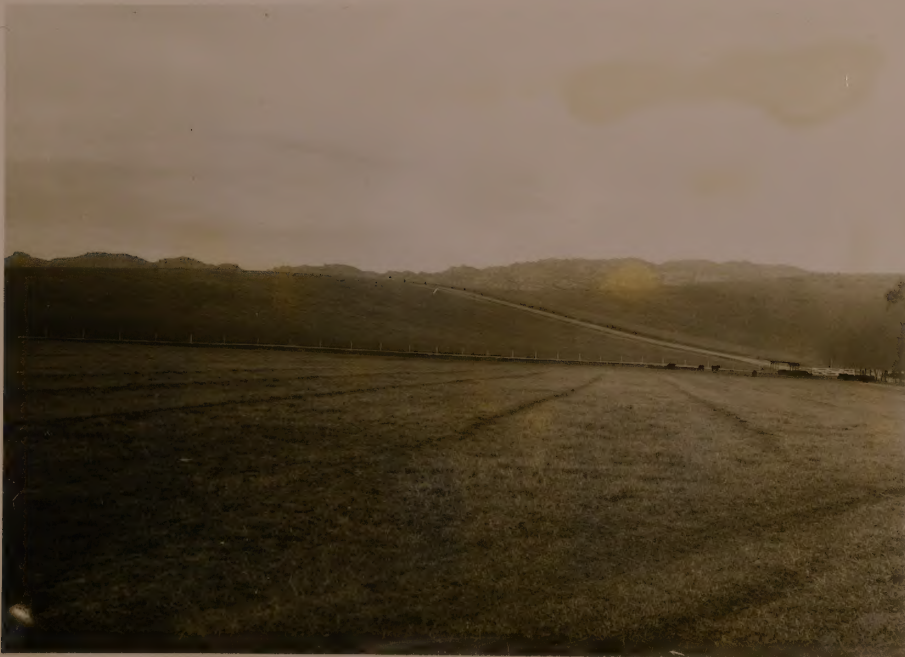
(18) Oil control for  
weeds. No cultivation.  
Litter on surface.  
Shallow, broad irriga-  
tion furrows. Soil  
firm. Cross checks  
effective.

(19) Contour cultivation and good ground cover  
prevented soil loss on this hill.

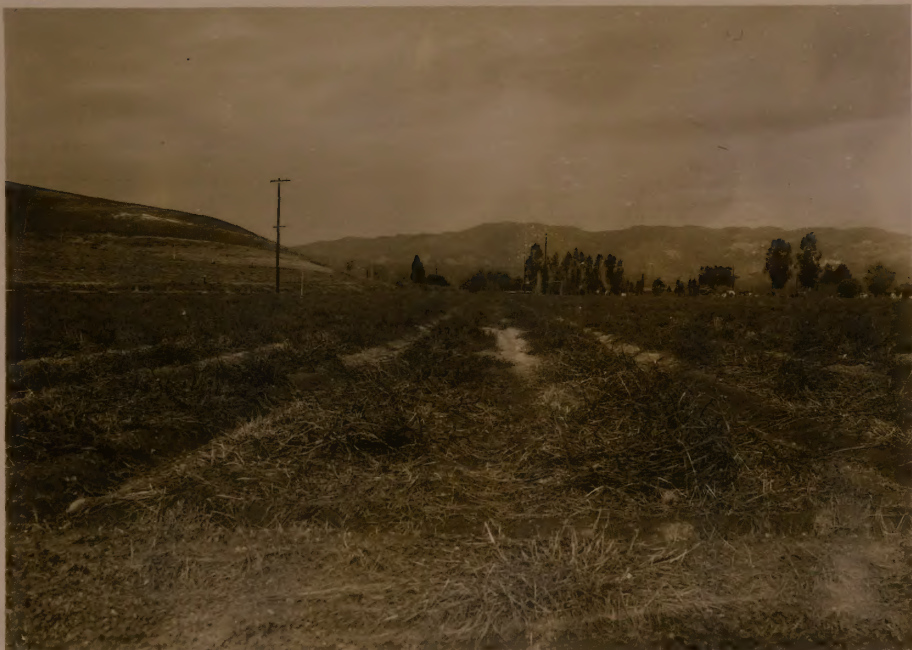
(18) All control for  
wood. No cultivation.  
Litter on surface.  
Shallow, broad ridge-  
like furrows. Soil  
firm. Grass checks  
effective.

(19) Control cultivation and good ground cover  
prevented soil loss on this hill.

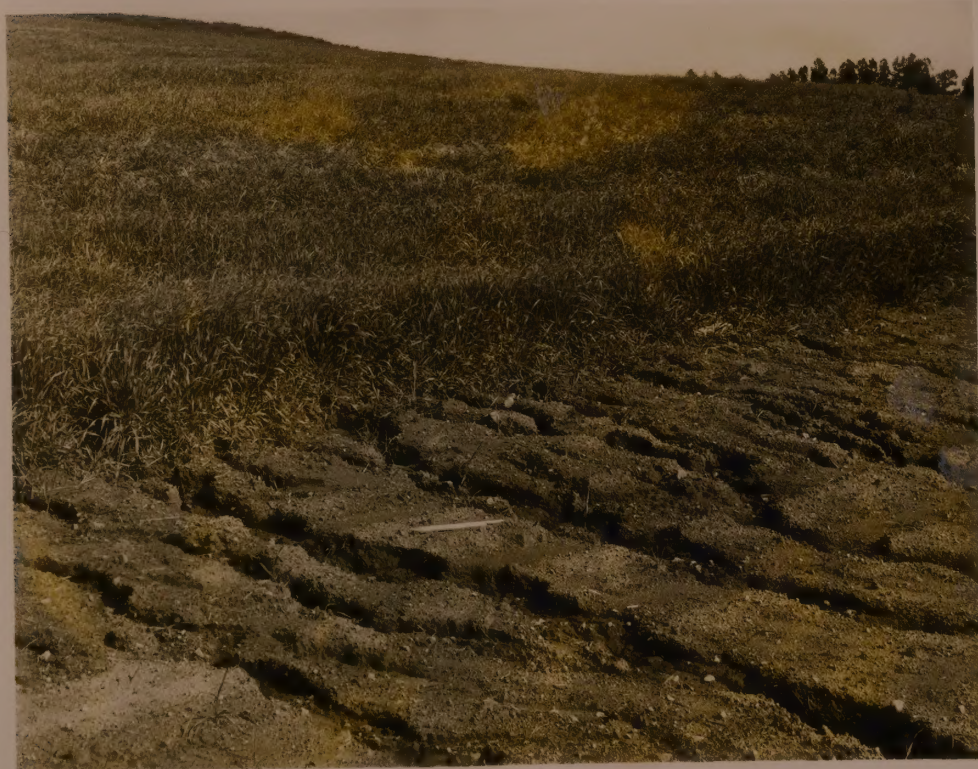
(20) Tomato vines on 1 to 2% slopes check soil loss.  
Note deposits in furrows.

(21) Erosion contrast under good cover and clean  
cultivated conditions.
